OVERSIGHT

Executive Summary

The West Valley Demonstration Project began the vitrification of high level radioactive waste on July 2, 1996. On Saturday, November 16, 1996, the facility experienced a migration of dilute radioactive material into the demineralized-water line outside of the confinement cell. The event occurred during backflushing operations intended to improve the sampling slurry flow rate. As a result of this material outside the cell, high radiation alarms were received in two of the operating aisles and the operating aisles were evacuated. After the event, the Department of Energy (DOE) and West Valley Nuclear Services (WVNS) management both commissioned teams to investigate the event and to propose corrective actions. On January 13, 1997, the DOE Office of Oversight conducted an independent followup review of the event and the corrective actions. The purpose of this review was to ensure that appropriate corrective actions were taken by management and to issue a report that could provide lessons learned to the DOE complex.

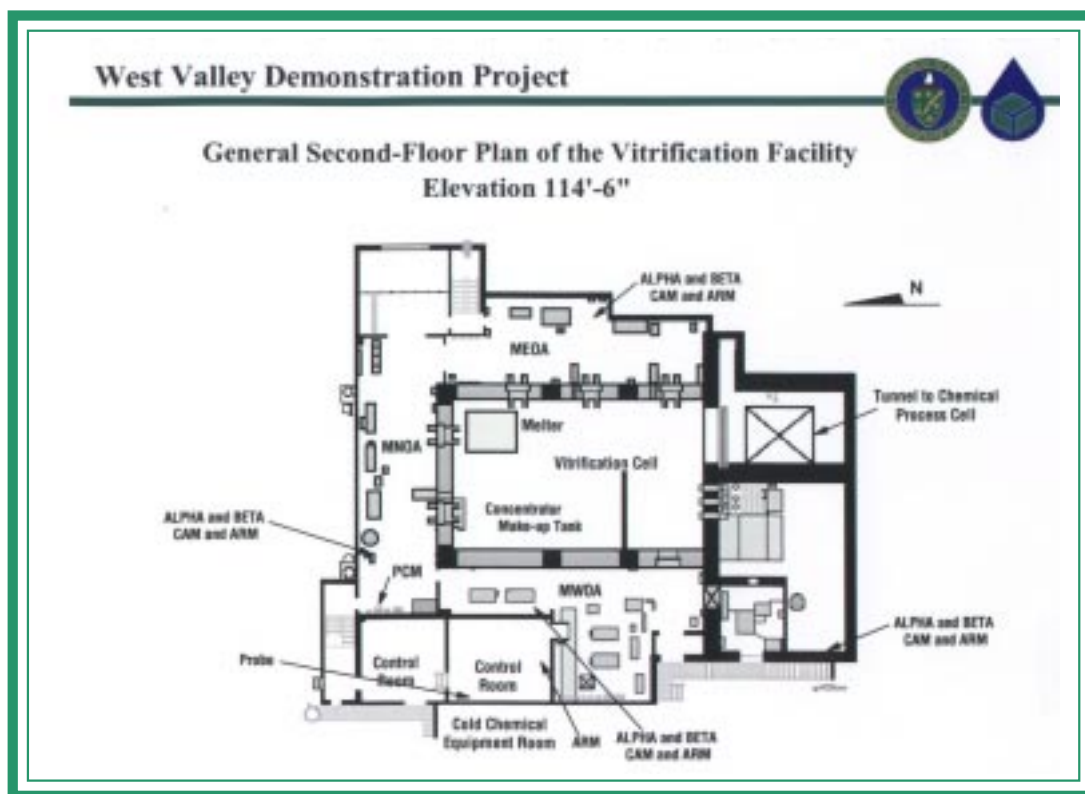
MNOA - Middle North Operating Aisle
MEOA - Middle East Operating Aisle

MWOA - Middle West Operating Aisle
